# **BREAKNECK DAM**

## **NJ 00425**

**PHASE 1 INSPECTION REPORT**  
**NATIONAL DAM SAFETY PROGRAM**

May, 1979

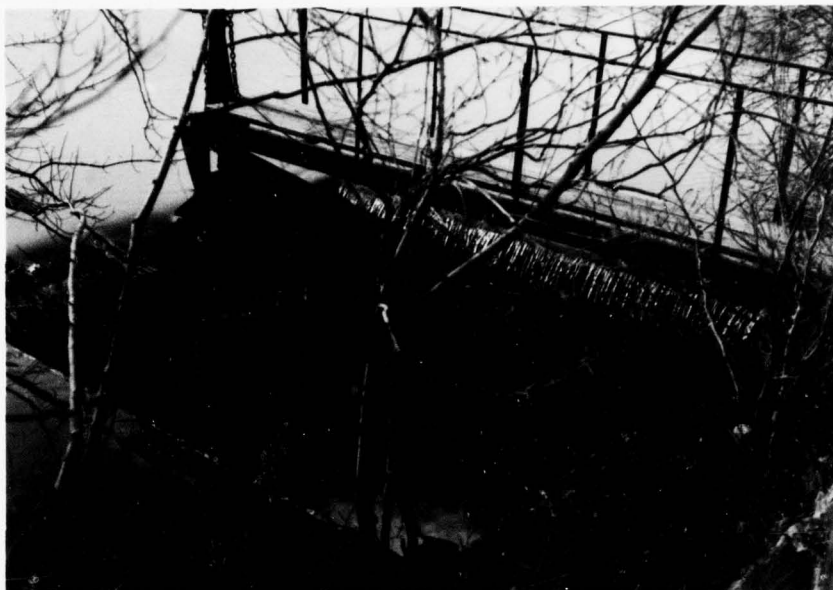
PHOTO 1  
PRIMARY SPILLWAY

The exposed portions of both concrete spillways generally were in good condition with exposed aggregate on the concrete surfaces. The submerged and buried portions were not inspected.

The tops of both spillways were open and readily accessible, constituting a serious physical safety hazard.

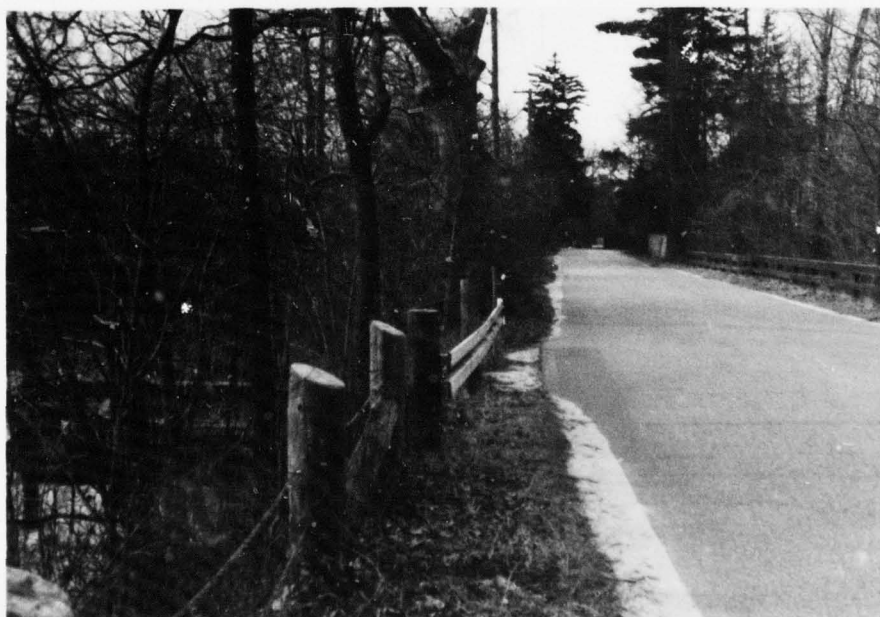
PHOTO 6

The embankment crest was generally level with a straight horizontal alignment leading to a slight northward curve at the east end. The paved crest road and adjoining areas were in good condition with slight erosion along the top of the side slopes from poor road drainage.

PAVED ROAD ON CREST OF DAM

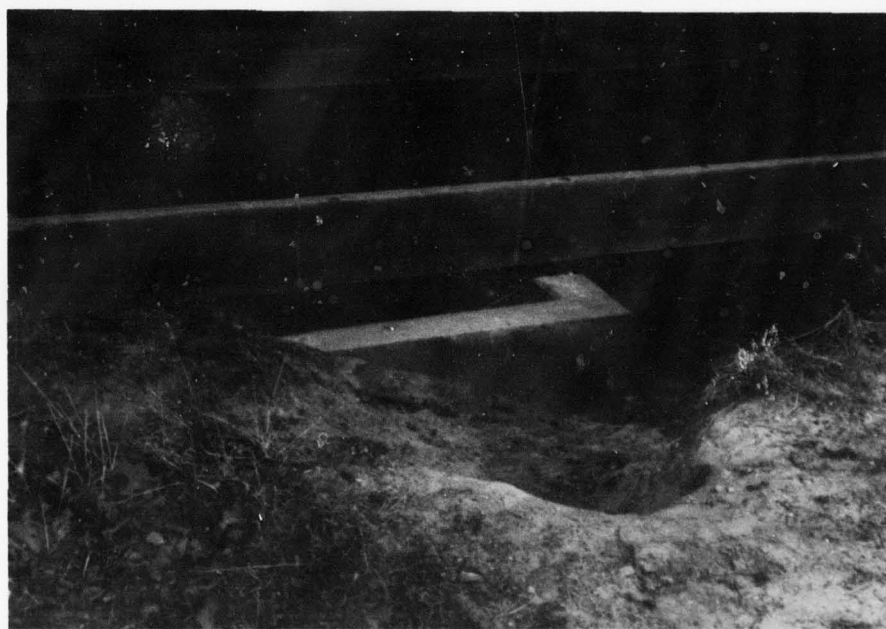
PHOTO 8

EROSION AT DOWNSTREAM HEADWALL FOR PRIMARY  
SPILLWAY DISCHARGE CULVERT.

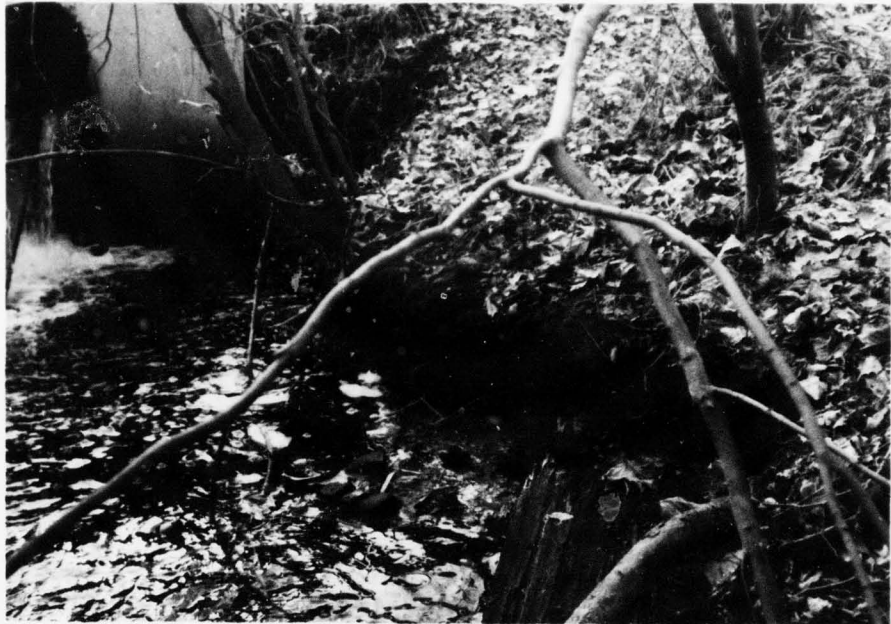
PHOTO 9

A stilling basin was observed at the outfall of the secondary spillway discharge culvert. The west bank of the natural channel downstream of this outfall has been undercut and eroded. Seepage was noted exiting from the undercut area (see Plate 5 and Photo 9) discharging as a trickle with some suspended orange silt.

SEEPAGE AT DOWNSTREAM CHANNEL
